8th International Conference on Sustainability in Energy and Buildings, SEB-16, 11-13 September
2016, Turin, ITALY

A new methodology for the selective measurement of building performance and safety

Littlewood, J. R.^{a*}, Alam, M.^a, Goodhew, S.^b

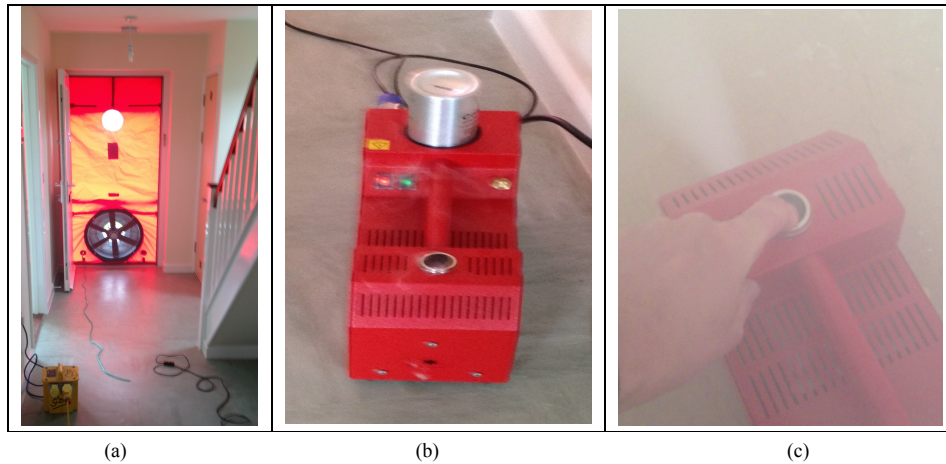
For smoke spread testing, the iCT methodology has used domestic air permeability test equipment operated as a pressure test (at 35Pa) and combined with cold smoke (Figure 1a) to identify air leakage paths and defects in compartmentation. Currently, iCT for smoke spread uses water based cold smoke which is a mixture of purified de-ionised water and glycol or glycerol as smoke fluid for creating cold smoke (Figure 1b). Glycol smoke starts to layer at 35-45°C while glycerol smoke at 50-60°C [19]. The iCT process involves fully filling a dwelling with the cold smoke, and then activating the blower door pressure test (Fig 1c). Smoke is then filmed with digital video cameras as it escapes from adjoining dwellings (vertically and horizontal) and also observed through a sense of smell, if it is not visible depending on the concentration in the adjoining dwellings, circulation routes for means of escape and also the roof space. The use of cold smoke testing is a useful test method, which may be representative of conditions of very small fire sizes where buoyancy effect of the fire heat will be negligible and smoke will follow the existing air circulation paths. However, cold smoke tests do not reproduce the real conditions of smoke, as in a real sizeable fire situation, where temperature of the smoke is similar to the fire and movement of smoke will be affected by buoyancy forces due to density difference between hot gases in smoke and ambient air, as well as the air expansion forces generated by heat from the fire. These initial tests were conducted at 35 Pa, which is much less than that will build up in real fire situations. Van den Brink [20] experimentally found that within a minute of fire ignition, in a fire test room size of 3.6m × 2.4m × 2.4m (length × width × height) peak pressure of 172 Pa was reached. Van den Brink [20] also

Fig. 1. (a) Blower door setup for pressure test (b) Cold smoke generator (c): Smoke generation with water based oil

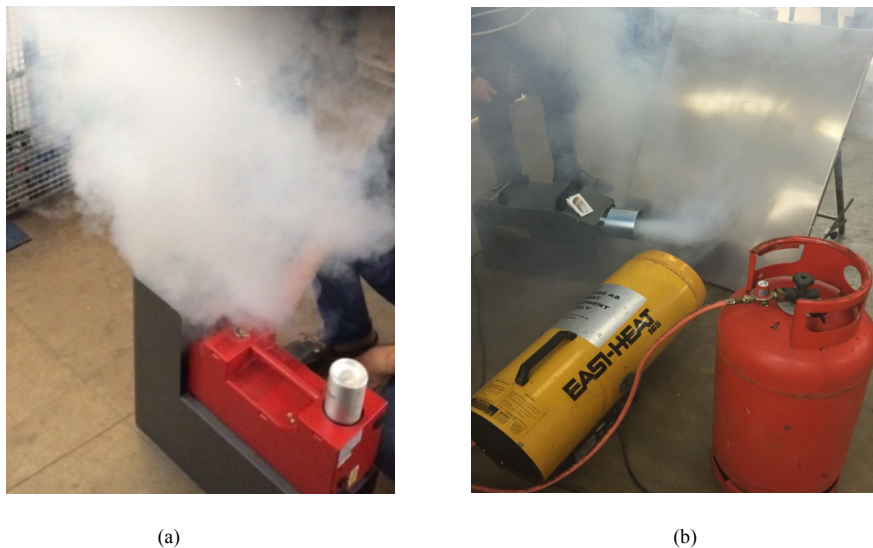
One potential method that is being explored is heating the water based cold smoke by mixing it with hot air generated by a space heater, in a vertical tube, replicating a ‘chimney’. However, one limitation of using water based smoke is that there is significantly low temperature resistance i.e. 35°C to 50°C and at increasing temperatures cold smoke starts to evaporate and disappear. This challenge can be overcome by using - mineral oil based smoke, which can resist temperatures up to 200°C [19]. Heating of oil based smoke can be achieved by using controlled alcohol fires, such as in a hot smoke test. Hot smoke tests are currently undertaken to test smoke control systems, such as smoke management systems in enclosed spaces of large volumes. For example, shopping centre atrium [21], tunnels [22], airports [23] underground car parks, exhibition halls and railway stations [24]. Hot smoke tests can produce thermally buoyant smoke using controlled alcohol fires directly beneath the smoke, where the smoke is generated with pyrotechnic smoke generators and this test has also been adopted in Australian National Standard ANS 4391:1999 [25]. Hot smoke tests require careful control of the fire source and the hot smoke to avoid damage to building materials. In hot smoke testing temperatures at ceiling height of a building is required to be less than 55°C, to avoid activation of sprinkler systems [26] and damage to plastic components in buildings, such as PVC cables with a melting point - between 75°C and 110°C. Therefore, this test does not replicate the smoke temperature conditions as in real fire situation in buildings where temperatures are more than 600°C in the vicinity of fire flame and is greater than 100°C at the ceiling height [26]. Also, building contractors and developers may not be in support of carrying out hot smoke testing with controlled alcohol fires due to potential increase in building insurance costs associated with naked flames on a live construction site where there may be flammable materials present on site. Therefore, researchers at Cardiff Metropolitan University are exploring how to generate thermally buoyant smoke, which can simulate real fire conditions without any risk to buildings. Such non-destructive testing should have more acceptability in the UK construction industry. Risks associated with controlled fires can be eliminated by using the space heater as a source of heat to produce thermally buoyant smoke. Figure 2 (a) shows the setup for heating water based cold smoke with the help of electrical heater and chimney [19]. Figure 2 (b) shows the use of oil based cold smoke heated with a propane heater and being directed vertically, using deflector plate [19].

Fig. 2. Heated smoke testing apparatus being trialled (a) water based cold smoke heated with electrical space heater (b) oil based smoke heated with propane gas heater [19].
